ASBESTOS SURVEY REPORT AND REGISTER

**LAWRENCEDALE COURT
69 WORTING ROAD
BASINGSTOKE
HAMPSHIRE
RG21 8FP**

February 2005

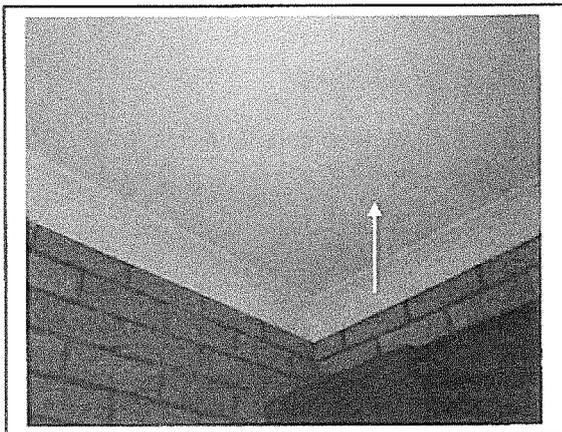
Block 1 GF.01 Ground Floor Hallway

Asbestos Type:	None detected	Fibre Content:	N/A
Product:	Textured coating	Condition:	N/A
Approx. Amount:	8m ²	Surface Treatment	N/A
Accessibility:	N/A	Exposed Population:	N/A
Position:	Internal	Disturbance Potential	N/A
Risk rating (Score):	N/A

Located to ceiling throughout area.

Similar textured coating located to ceilings in the following areas within Block 1:

SA.01 and 1F.01

Total amount approx. 28m².

No asbestos detected in sample.

Action required:	None
Action due date:	N/A

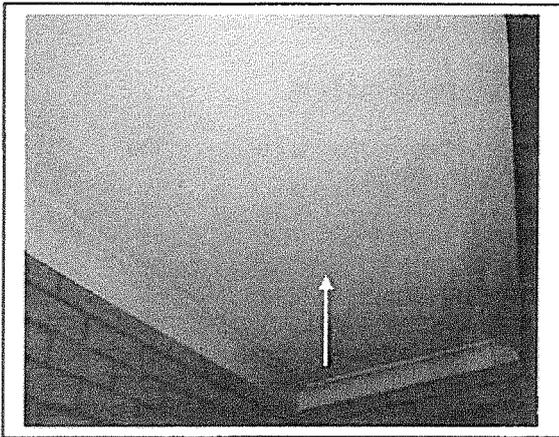
Block 2 GF.02 Ground Floor Hallway

Asbestos Type:	None detected	Fibre Content:	N/A
Product:	Textured coating	Condition:	N/A
Approx. Amount:	8m ²	Surface Treatment	N/A
Accessibility:	N/A	Exposed Population:	N/A
Position:	Internal	Disturbance Potential	N/A
Risk rating (Score):	N/A

Located to ceiling throughout area.

Similar textured coating located to ceilings in the following areas within Block 2:

SA.02 and 1F.02

Total amount approx. 28m².

No asbestos detected in sample.

Action required:	None
Action due date:	N/A
