Combined Health, Safety and Fire Risk Assessment.

Reference Number:	FRA No. AGO/WELLMAN
Address of Premises:	Lawrence Dale Court Basingstoke RG21 8FP
Responsible person (e.g. employer) or person having control of the premises:	Wellman Property Management Ltd
Person (s) consulted:	No occupier or other relevant person available to consult
Assessor:	Rob Cockburn
Quality Control Auditor (If Required):	John Godfrey, GIFireE.
Date of assessment:	31 st October 2023
Date of previous assessment:	12 th July 2022
Suggested dates for review: (1)	October 2024

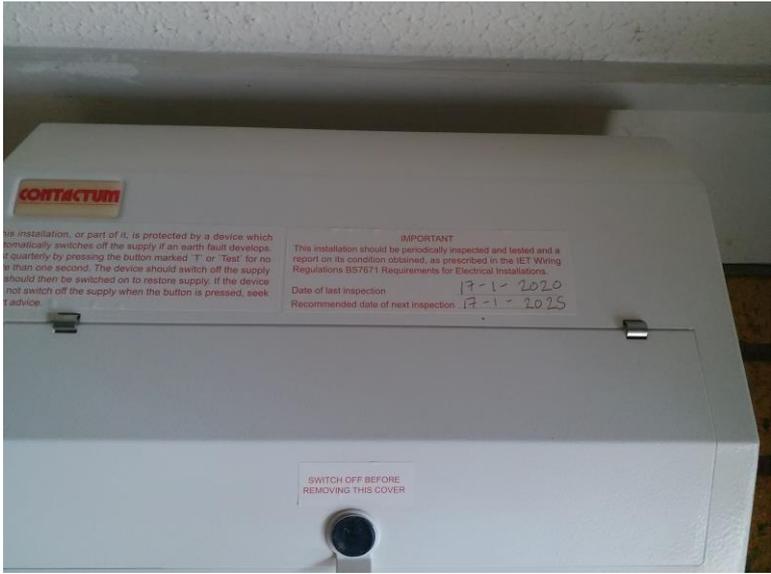
FIRE RISK ASSESSMENT ACTION PLAN				
It is considered that the following recommendations should be implemented in order to reduce fire risk to, or maintain it at, the following levels: Trivial or Tolerable				
Action	Detail (to be read in conjunction with the report findings)	Priority	Action by whom	Date action undertaken
01	<p>According to the sticker attached to the consumer unit, the fixed electrical installation was last inspected and tested in January 2020 and March 2021.</p> <p>All fixed electrical installations supplying the communal areas of a residential property should be inspected and tested by a competent person every five years in accordance with Electricity at Work Regulations / IEE Wiring Regulations Eighteenth Edition 2019 / British Standard 7671: 2018 and a written Electrical Condition Report (EICR) obtained.</p> <p>It is recommended that the RP create a management action to ensure the electrical installation is retested on a five yearly rolling basis.</p>

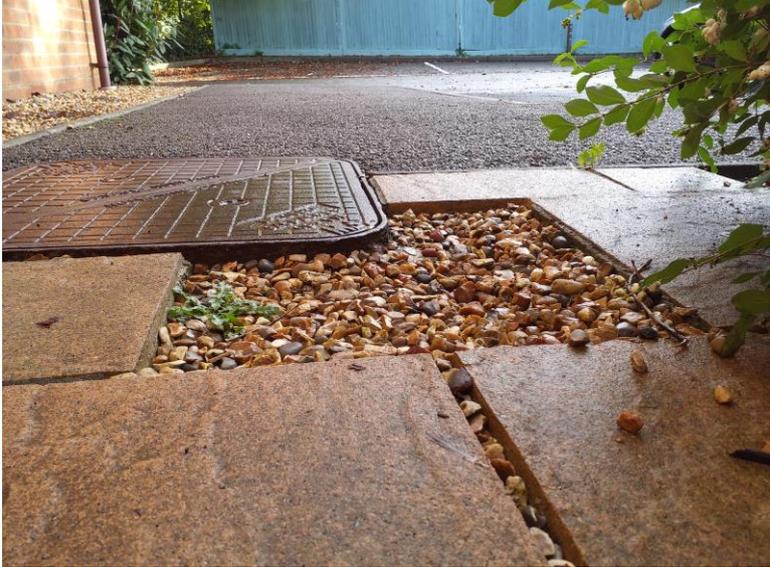
<ul style="list-style-type: none"> • Is the car park surface reasonably level and free from potholes or similar? 	YES
13.2	Comments and hazards observed:	
	<p>It was noted during this risk assessment that a paving slab was missing from the main pathway walkway to block 1-8. This has created different levels on the pavement which could present a trip hazard it is therefore recommended that the RP instructs a competent contractor to replace the missing slab.</p> <p>It was further noted that the car park area had moss and a large accumulation of leaves and horse chestnut shells which could become slippery when wet and present a slip hazard. It is therefore recommended that the RP instructs a competent contractor to clear the car park of all slip hazards.</p> <p>It was further noted that tree stumps were protruding from the grass in multiple areas around block 9-16. The RP has informed that these are being removed by a competent contractor on the 17th November. Once the stumps have been removed it is recommended that the area is levelled out.</p> <p>The surrounding areas of the premises including hard and soft landscaping and car parking should be periodically inspected by the RP and the results of each inspection recorded.</p> <p>Refer to 14.0 for door mats.</p>

02	<p>It was noted during this fire risk assessment that a paving slab was missing from the main pathway walkway to block 1-8. This has created different levels on the pavement which could present a trip hazard it is therefore recommended that the RP instructs a competent contractor to replace the missing slab.</p>

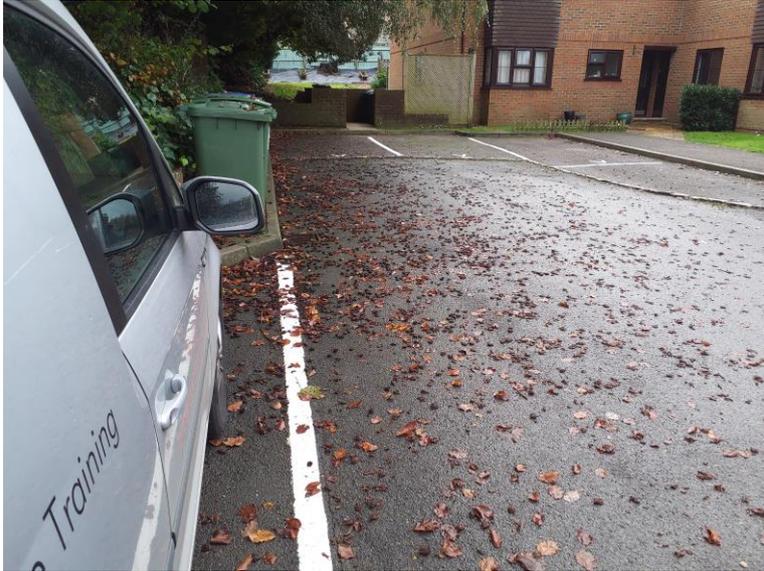
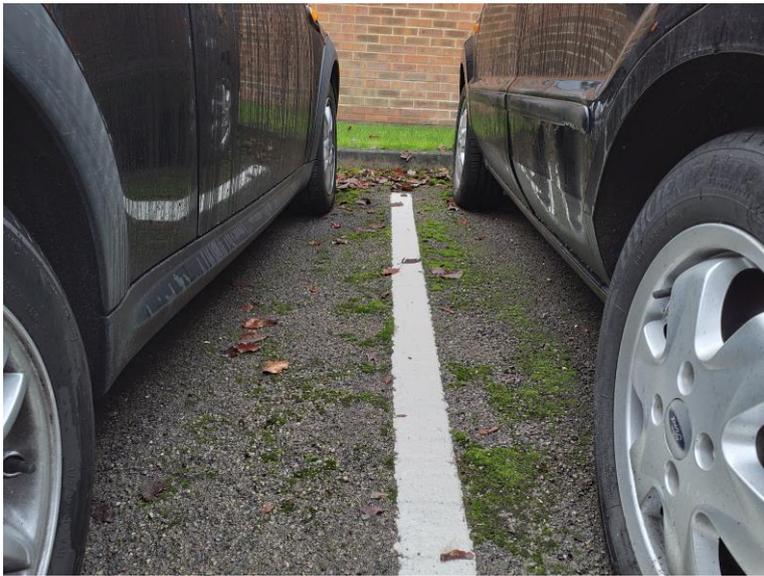
It was further noted that the car park area had moss and a large accumulation of leaves and horse chestnut shells which could become slippery when wet and present a slip hazard. It is therefore recommended that the RP instructs a competent contractor to clear the car park of all slip hazards.

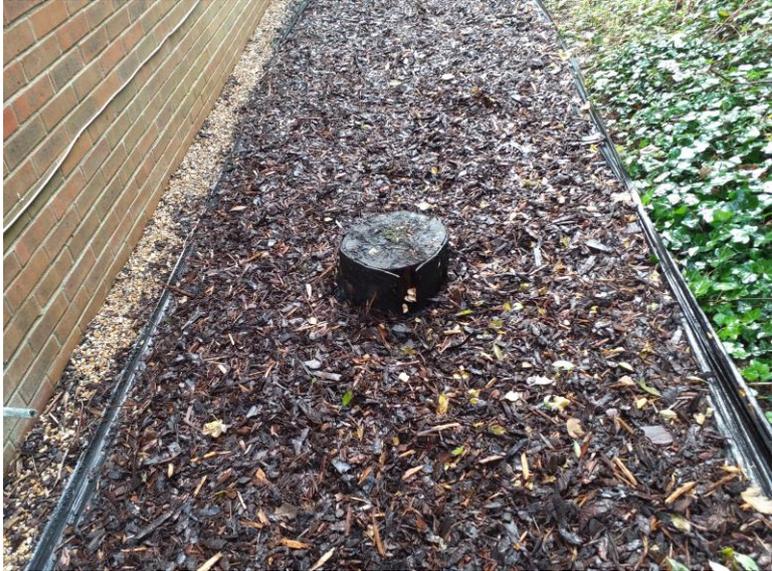
04	<p>It was further noted that tree stumps were protruding from the grass in multiple areas around block 9-16. The RP has informed that these are being removed by a competent contractor on the 17th November. Once the stumps have been removed it is recommended that the area is levelled out.</p>

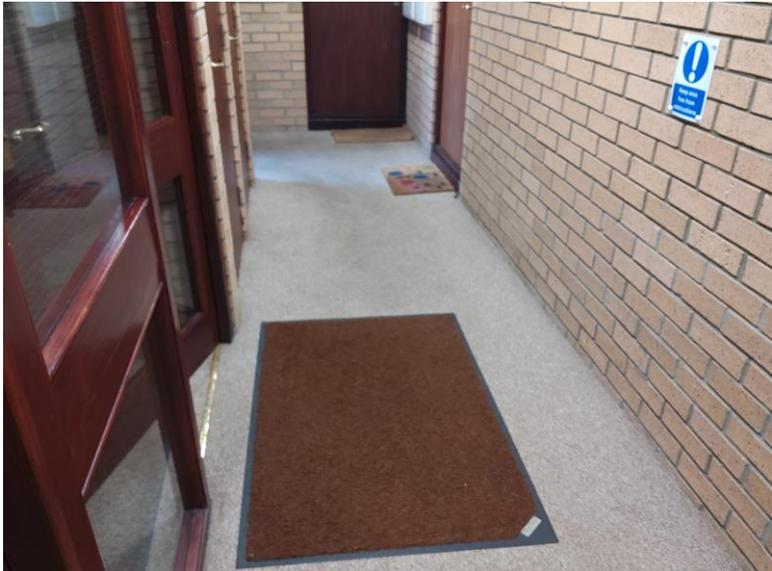
14.1	Comments and hazards observed:	
	<p>The RP enforces a zero-tolerance approach meaning that communal areas should remain sterile at all times as per the guidance within Local Government Publication – Fire Safety in Purpose Built Flats Section 44.11. It is therefore recommended that all door mats are removed from the communal area to adhere to the zero-tolerance approach.</p> <p>Waste is well managed.</p>

LOW	Client	
05	<p>The RP enforces a zero-tolerance approach meaning that communal areas should remain sterile at all times as per the guidance within Local Government Publication – Fire Safety in Purpose Built Flats Section 44.11. It is therefore recommended that all door mats are removed from the communal area to adhere to the zero-tolerance approach.</p>

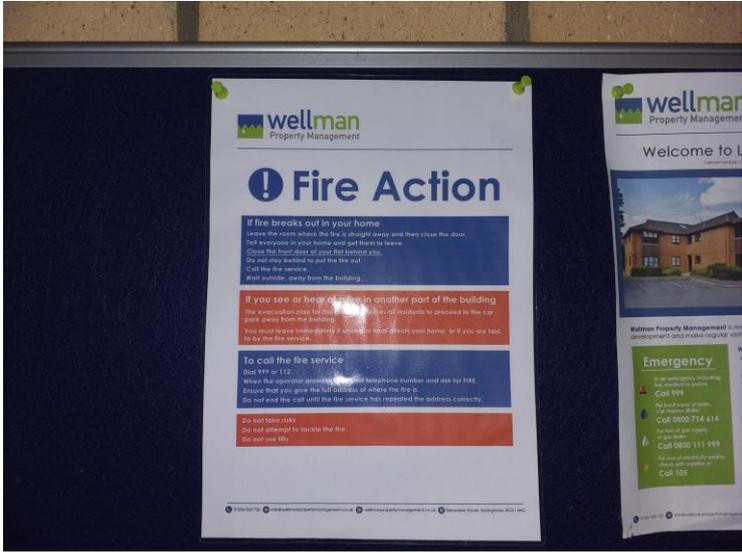
21.8	Comments and deficiencies observed:	
	It was noted during this fire risk assessment that the fire action notice had the incorrect fire evacuation strategy. It is recommended that a new fire action notice be installed by each final exit that refers to the correct evacuation strategy for this premises, which is stay put. Directional signage is suitable and sufficient.

<p>10</p>	<p>It was noted during this fire risk assessment that the fire action notice had the incorrect fire evacuation strategy. It is recommended that a new fire action notice be installed by each final exit that refers to the correct evacuation strategy for this premises, which is stay put.</p>

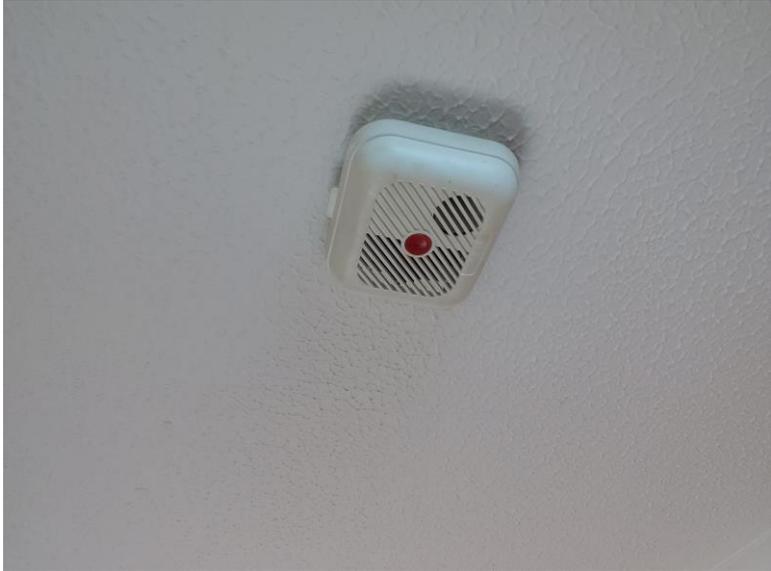
22.6	Are call points unobstructed?	N/A
22.7	Comments and deficiencies observed:	
	<p>It was noted during this fire risk assessment that smoke detectors were present within the communal area. This could be considered an over precaution within a purpose-built block of flats. It is recommended that these are removed to support the stay put policy of the premises.</p> <p>Each flat is responsible for their own fire precautions and it is recommended that the RP advise each resident of the importance of installing smoke detectors within their flat. One battery operated smoke detector in the lobby of each flat would be the minimum provision, however mains powered smoke detectors, each with a battery backup, installed within the escape route of each flat, in all rooms that communicate with the escape route and a heat detector within the kitchen, interlinked to form a BS5839-6: 2019 Grade D detection system with LD2 coverage would be the preferred and safest option for each occupant.</p>

<p>MED</p>	<p>Client</p>	
<p>11</p>	<p>It was noted during this fire risk assessment that smoke detectors were present within the communal area. This could be considered an over precaution within a purpose-built block of flats. It is recommended that these are removed to not conflict with the stay put policy of the premises.</p>
