**Re:- Installation of new storm water system**

We were advised to give a quotation to install new storm soakaways to both properties at Lawrence Dale Court, Basingstoke due to damp issues in the buildings.

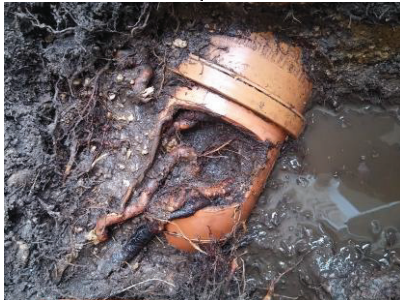
From previous works performed it is known that many of the storm water underground drains have been heavily infiltrated with roots. When roots block storm water pipes they will be in the pipe and take up 100% of the existing diameter. They will be in too much to root cut which means the pipes will have to be dug up and replaced.

Here is an example of roots in a storm water drain:

We would re-route the existing rainwater pipes around the building installing access points in the way of an inspection pot. From the inspection pot we would divert the storm water to the existing soakaway which currently takes all of the road gullies. **Please see drawing.**
